Pipeline Investigation Report PIR-26-01

# Atmos Energy Corporation Natural Gas-Fueled Home Explosions and Fires

Jackson, Mississippi

January 24, 2024, and January 27, 2024

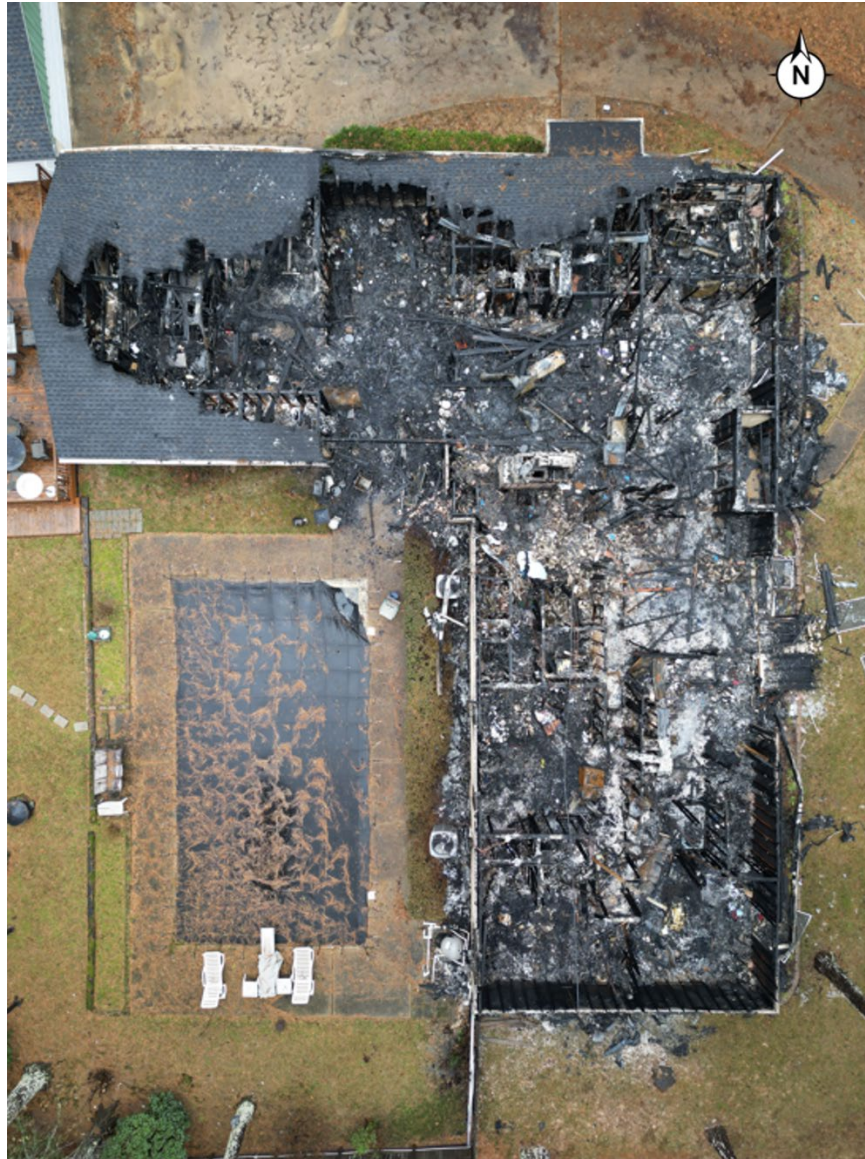
The explosion and fire destroyed the Bristol Boulevard accident home. (See figure 4.) Emergency medical services arrived on the scene and treated the Bristol Boulevard accident homeowner for a minor injury. After the Jackson Fire Department extinguished the fire, they found the Bristol Boulevard accident

**Figure 4.** Aerial photograph of the Bristol Boulevard accident home after the explosion and fire. (Courtesy of Atmos.)

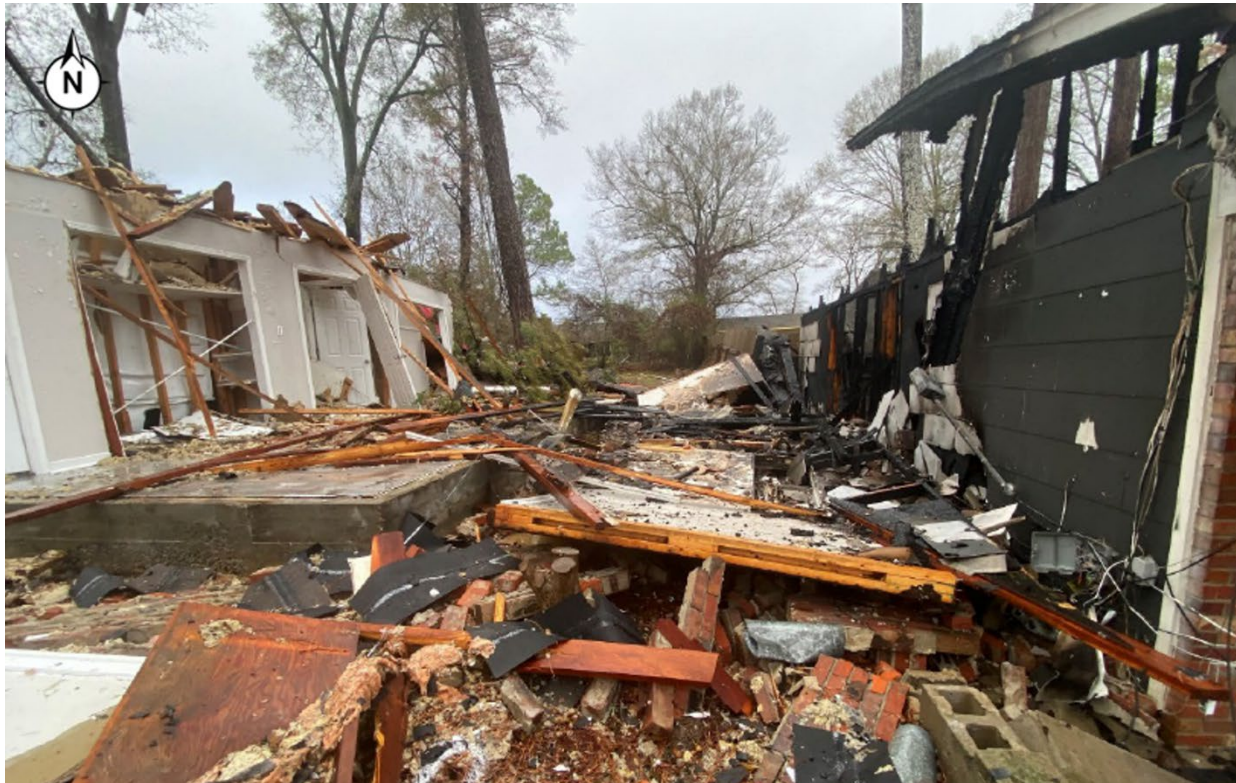
The explosion and fires destroyed the Shalimar Drive accident home and the Shalimar Drive affected home. (See figure 7.) Table 2 shows a timeline of the Shalimar Drive accident events.

**Figure 7.** The Shalimar Drive accident home (left) and the Shalimar Drive affected home (right) after the explosion and fires. (Courtesy of the Mississippi Public Service Commission.)

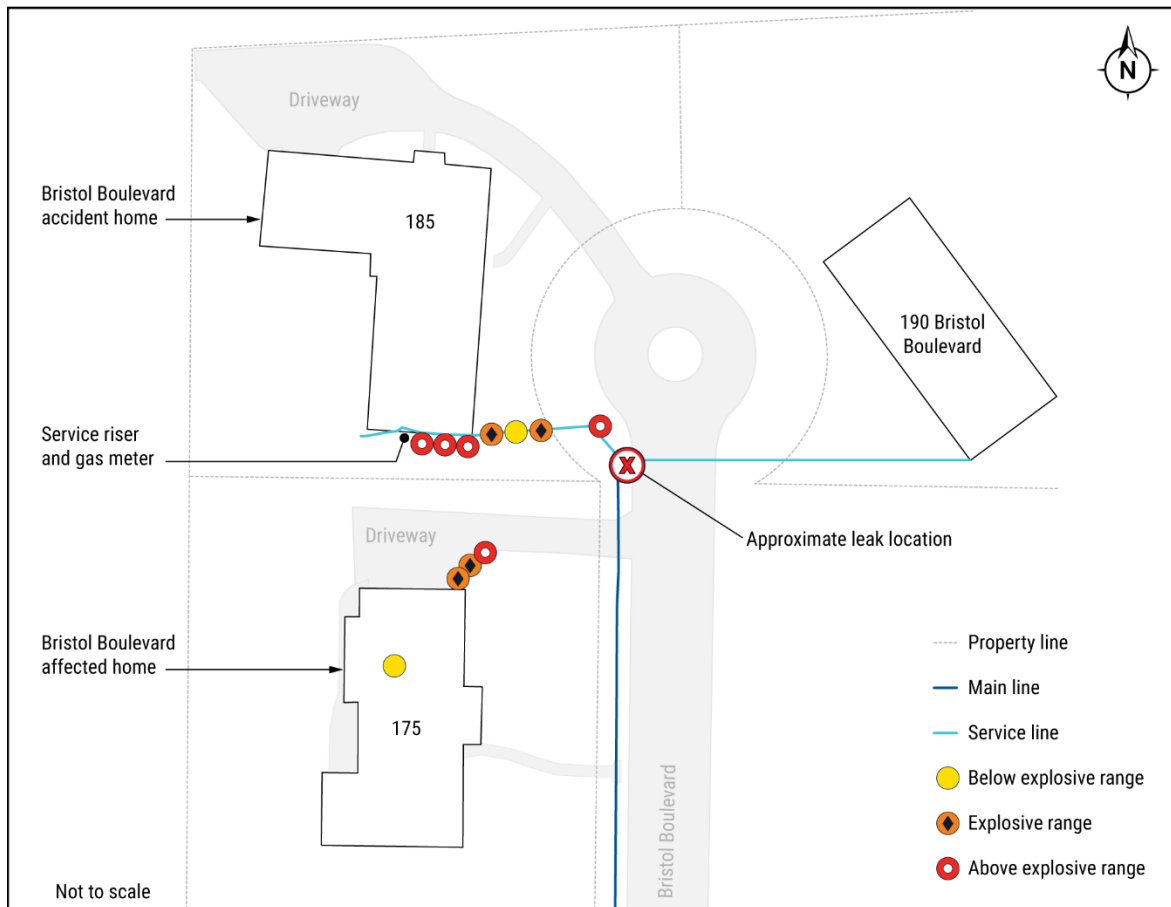
**Figure 10.** Postaccident bar-hole testing and open-air testing conducted at Bristol Boulevard on January 24, 2024, about 12:42 p.m.

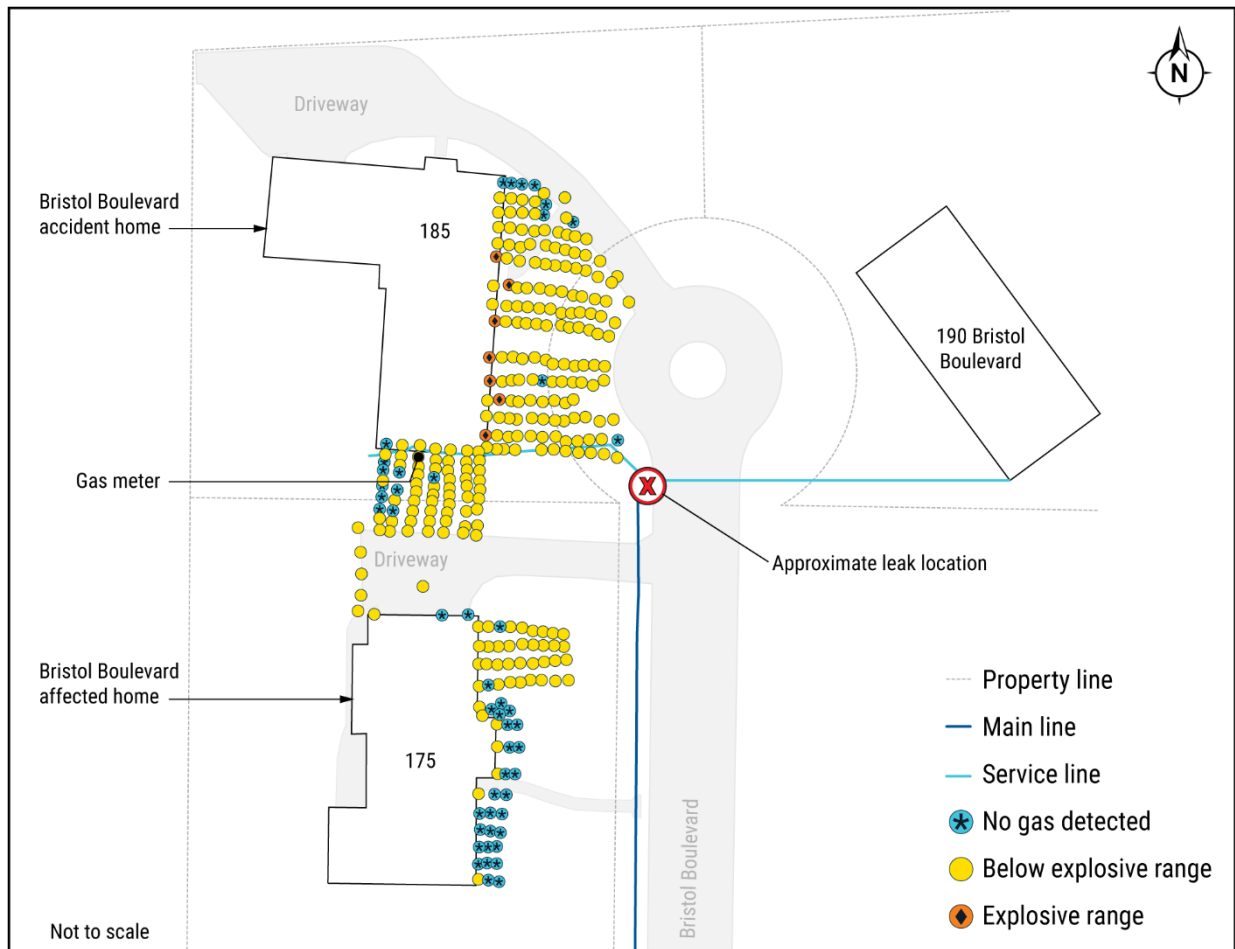
On January 29, 2024, 5 days after the explosion, about 9:15 a.m., Atmos conducted bar-hole testing and open-air testing under NTSB direction at the Bristol Boulevard accident location. This testing detected subsurface natural gas around the Bristol Boulevard accident home and the Bristol Boulevard affected home. This was residual gas that was still present in the soil in the days following the accident. Atmos had not restored natural gas service at the time of these tests. Test readings ranged from 0.0015% to 5.8% gas in air by volume. Figure 11 shows the results of this testing.

**Figure 11.** Postaccident bar-hole testing and open-air testing conducted at Bristol Boulevard on January 29, 2024, about 9:15 a.m.

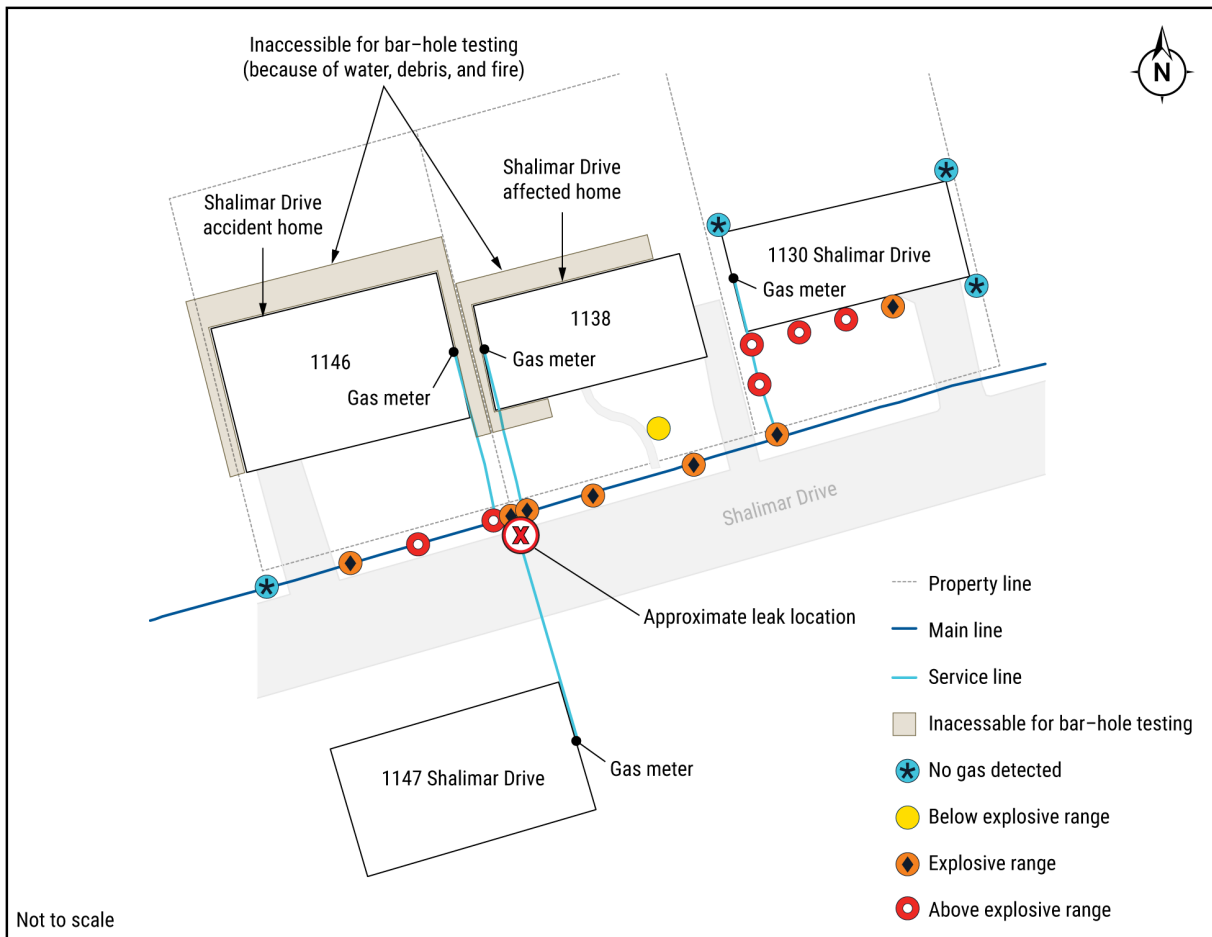
On January 27, 2024, shortly after the explosion, about 5:30 a.m., Atmos conducted bar-hole testing and open-air testing at the Shalimar Drive accident location. Atmos detected subsurface natural gas near the main in front of the Shalimar Drive accident home, the Shalimar Drive affected home, and the home at 1130 Shalimar Drive. Atmos also detected subsurface gas between the main and the Shalimar Drive accident home and the Shalimar Drive affected home. Test readings ranged from 0.25% to 50% gas in air by volume. Figure 12 shows the results of this testing and indicates whether each result was above, below, or within the explosive range of natural gas, which is between 5% and 15% gas in air by volume.

**Figure 12.** Postaccident bar-hole testing and open-air testing conducted at Shalimar Drive on January 27, 2024, about 5:30 a.m.

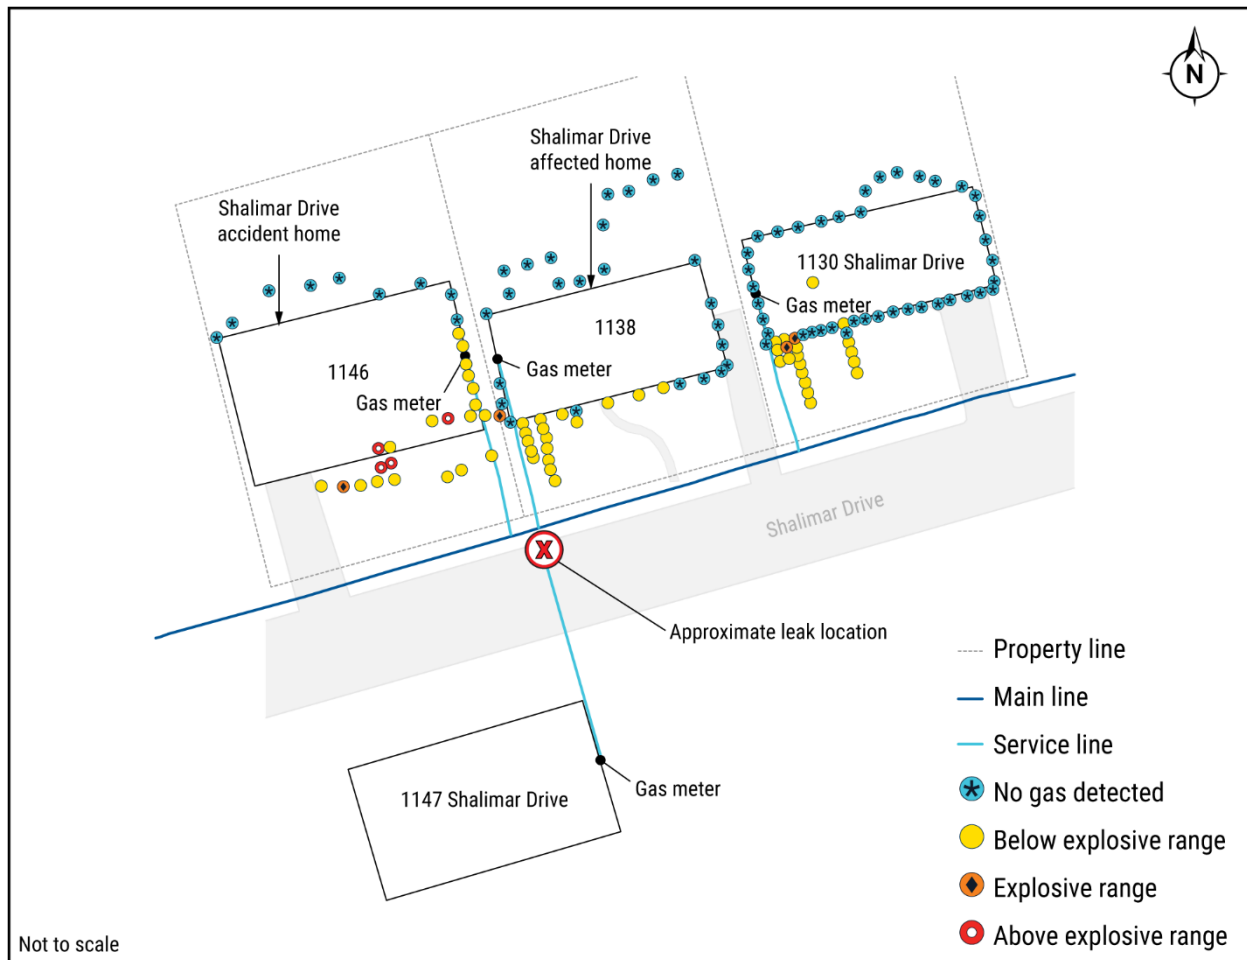
On January 29, 2024, 2 days after the explosion, about 9:40 a.m., Atmos conducted bar-hole testing and open-air testing under NTSB direction at the Shalimar Drive accident location. This testing detected subsurface natural gas near the Shalimar Drive accident home, the Shalimar Drive affected home, and the home at 1130 Shalimar Drive. The testing also identified open-air natural gas concentrations inside the home at 1130 Shalimar Drive. This was residual gas that was still present in the soil and air in the days following the accident. Atmos had not restored natural gas service at the time of these tests. Test readings ranged from 0.005% to 50.7% gas in air by volume. Figure 13 shows the results of this testing.

**Figure 13.** Postaccident bar-hole testing and open-air testing conducted at Shalimar Drive on January 29, 2024, about 9:40 a.m.

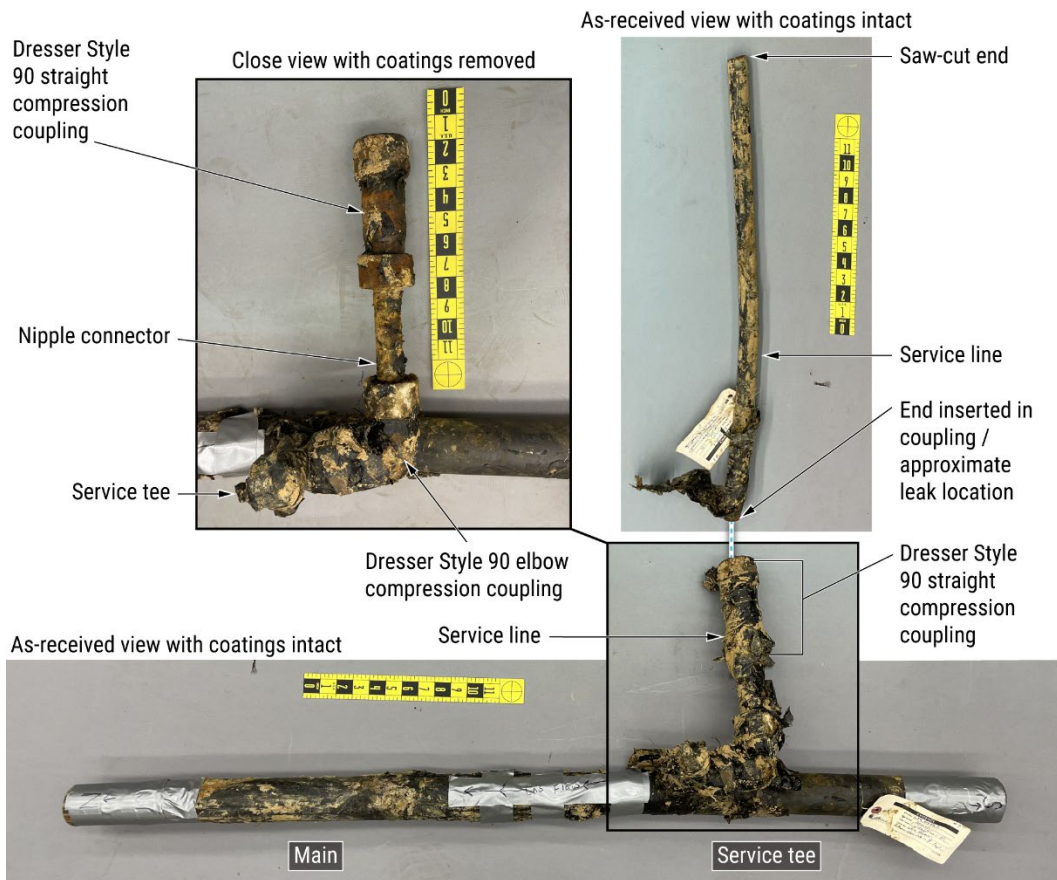
<sup>45</sup> The figure also indicates the approximate leak location.

**Figure 14.** The Bristol Boulevard natural gas pipeline assembly.

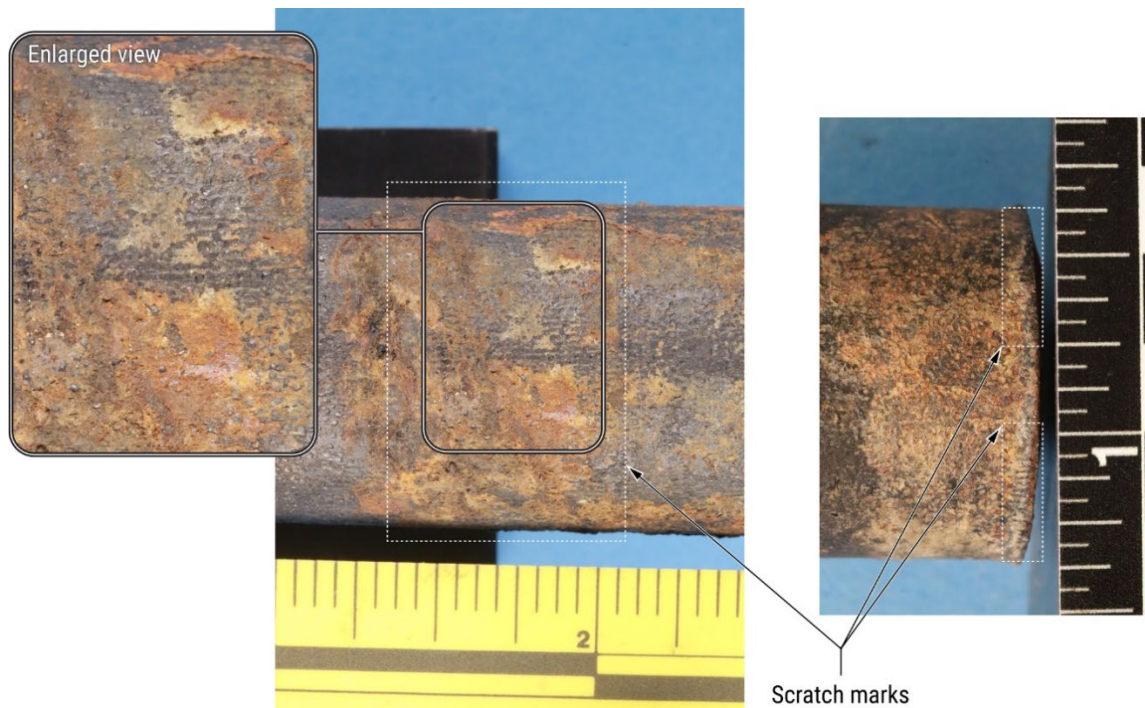
approximately 0.02 inches apart. The examination found scratches of similar size and shape at the end of the service-line pipe.<sup>48</sup> (See figure 15.)

**Figure 15.** Scratches on the upstream end of the service line at Bristol Boulevard.

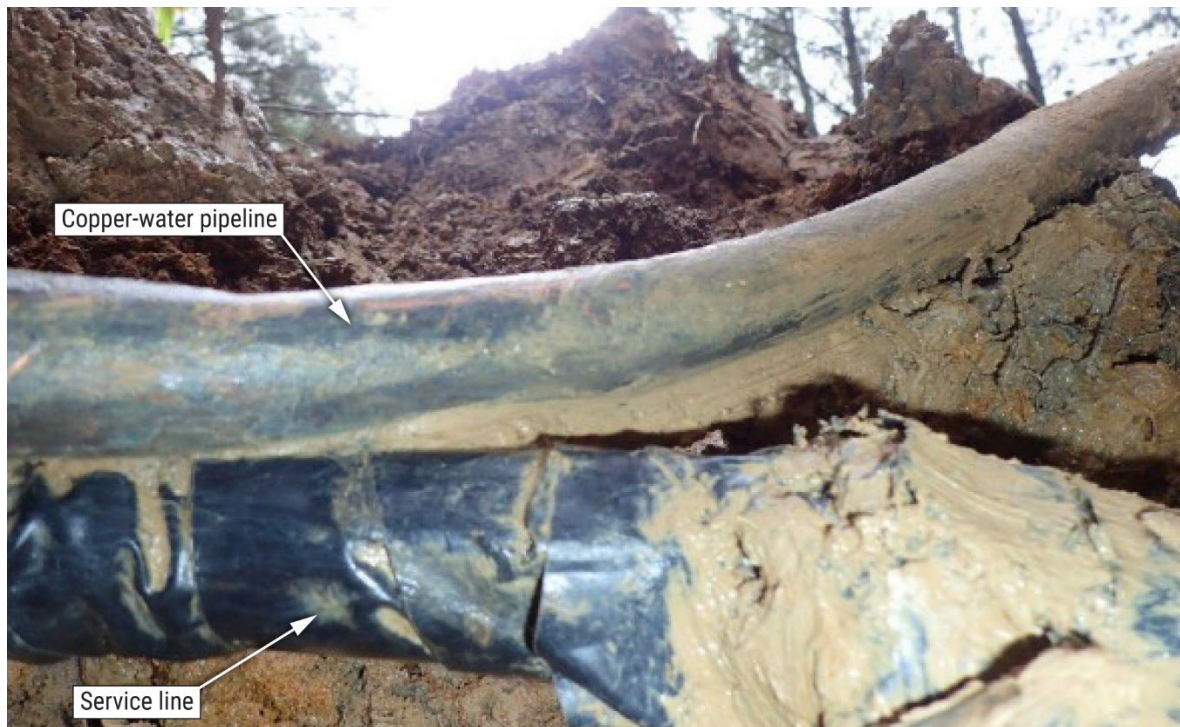
The NTSB examined a copper-water pipeline assembly that was installed above the service line to the home at 190 Bristol Boulevard and had rested near the connection between the compression coupling and the service-line pipe. The examination did not reveal any significant evidence of contact either on the top of the service line or on the bottom of the copper-water pipeline, such as evidence of rubbing, local deformation, or material transfer. Figure 16 is a postaccident-excavation photograph showing the copper-water pipeline traversing over the service line.

**Figure 16.** Excavation photograph of the copper-water pipeline and the service line near the Bristol Boulevard accident location. (Courtesy of Atmos.)

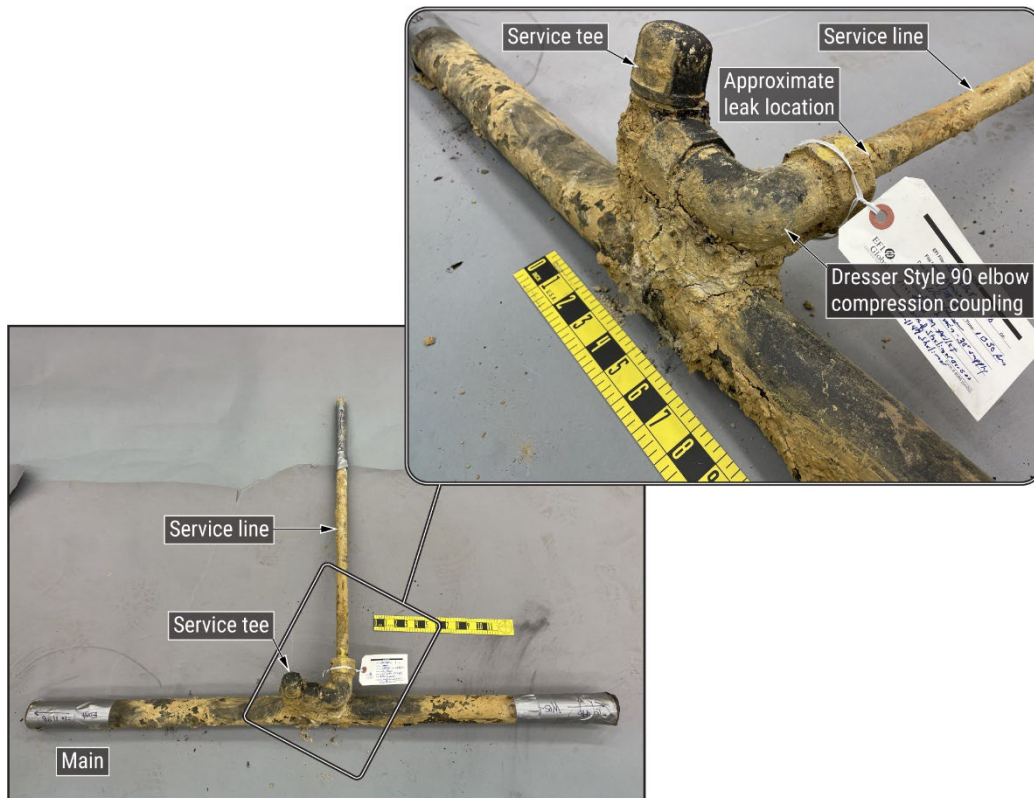
(See figure 17.)<sup>55</sup> NTSB pressure tests confirmed Atmos pressure testing on the scene, which found the leak on the Dresser Style 90 elbow compression coupling, pinpointing the connection between the compression coupling and the service line to the home at 1147 Shalimar Drive.

**Figure 17.** The Shalimar Drive natural gas pipeline assembly.

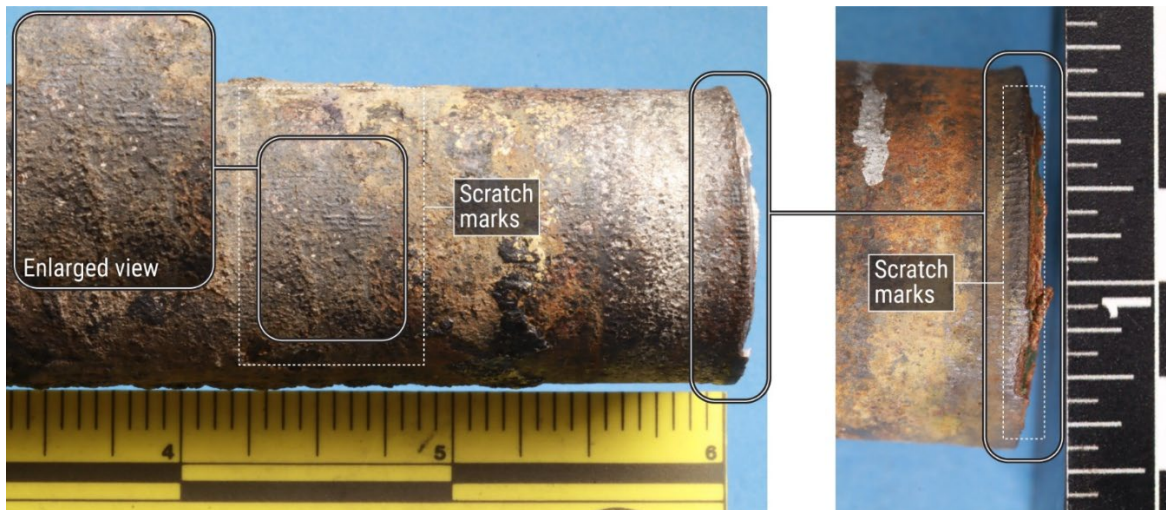
**Figure 18.** Scratches on the upstream end of the service line at Shalimar Drive.

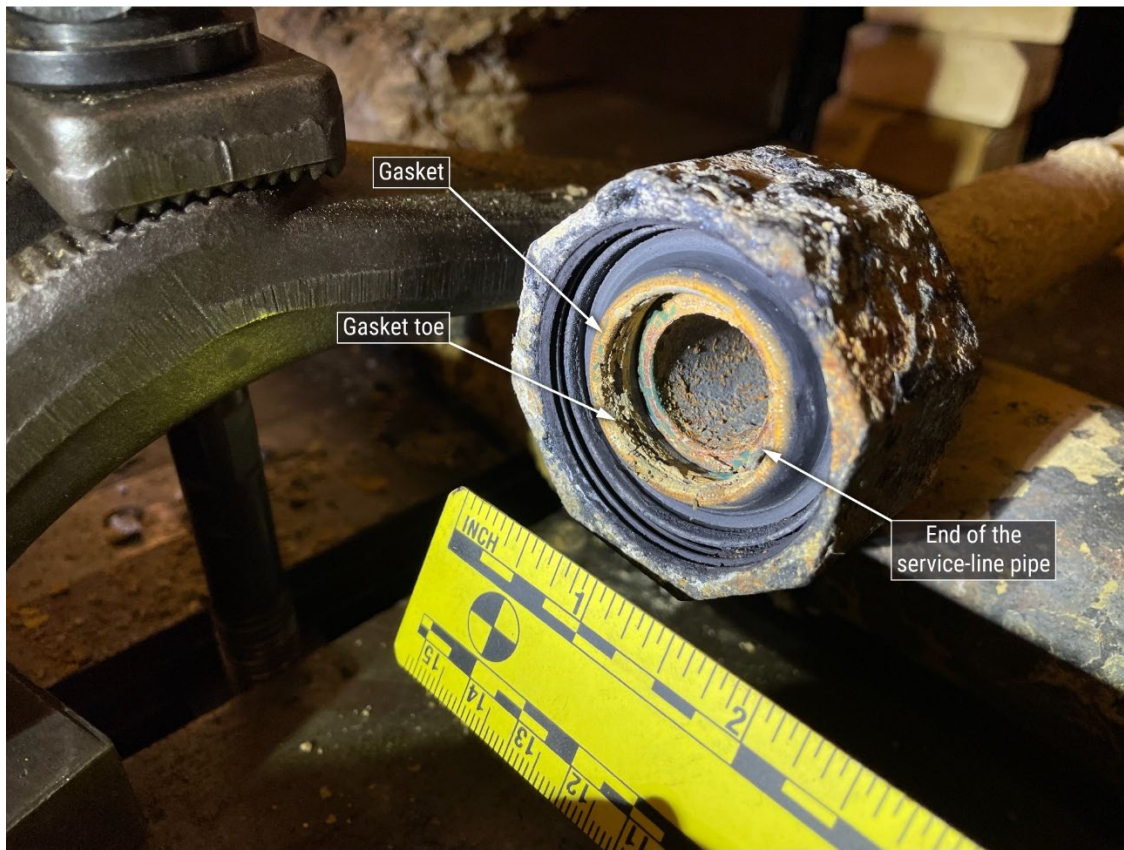
the compression coupling, meaning the service-line pipe was not fully inserted into the coupling, it had partially pulled out. (See figure 19.)<sup>56</sup>

**Figure 19.** The Shalimar Drive service-line pipe and gasket.

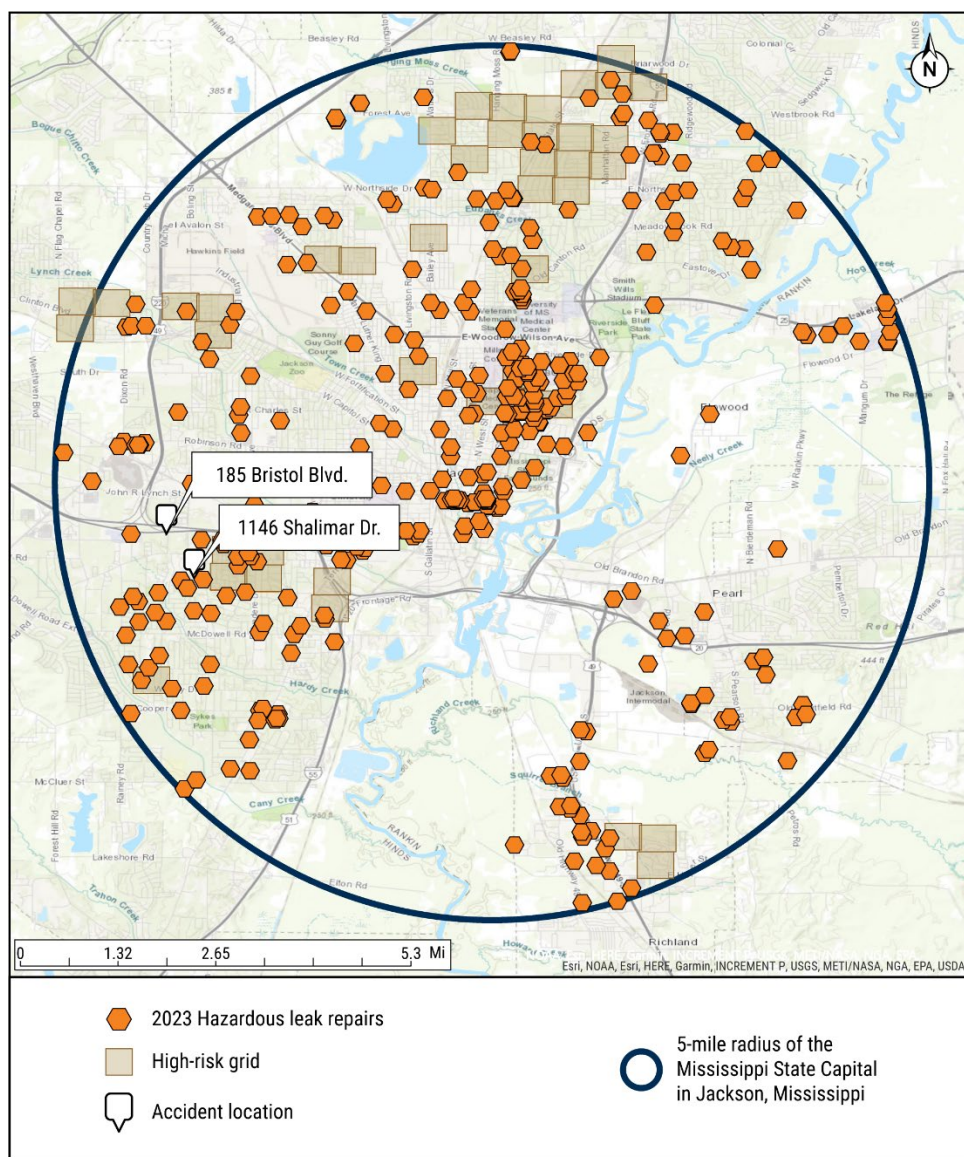
before the two accidents, Atmos repaired 182 hazardous (grade 1) leaks in Jackson. Although the repaired hazardous leaks were confirmed risks to Atmos's system, its risk model, in large part, did not rank the locations of the hazardous leaks as high risk. Figure 23 shows the hazardous leaks that Atmos repaired in 2023 within a 5-mile radius of Jackson overlaid with the Atmos risk model's high-risk grids that were current on that date; not many of the hazardous leaks are in high-risk grids.

**Figure 23.** Map of hazardous leaks within a 5-mile radius of Jackson that Atmos repaired in 2023 overlaid with Atmos high-risk grids current on that date. (Courtesy of ESRI ArcGIS and Atmos with NTSB annotations.)
