Pipeline Investigation Report PIR-26-01

# Atmos Energy Corporation Natural Gas-Fueled Home Explosions and Fires

Jackson, Mississippi

January 24, 2024, and January 27, 2024

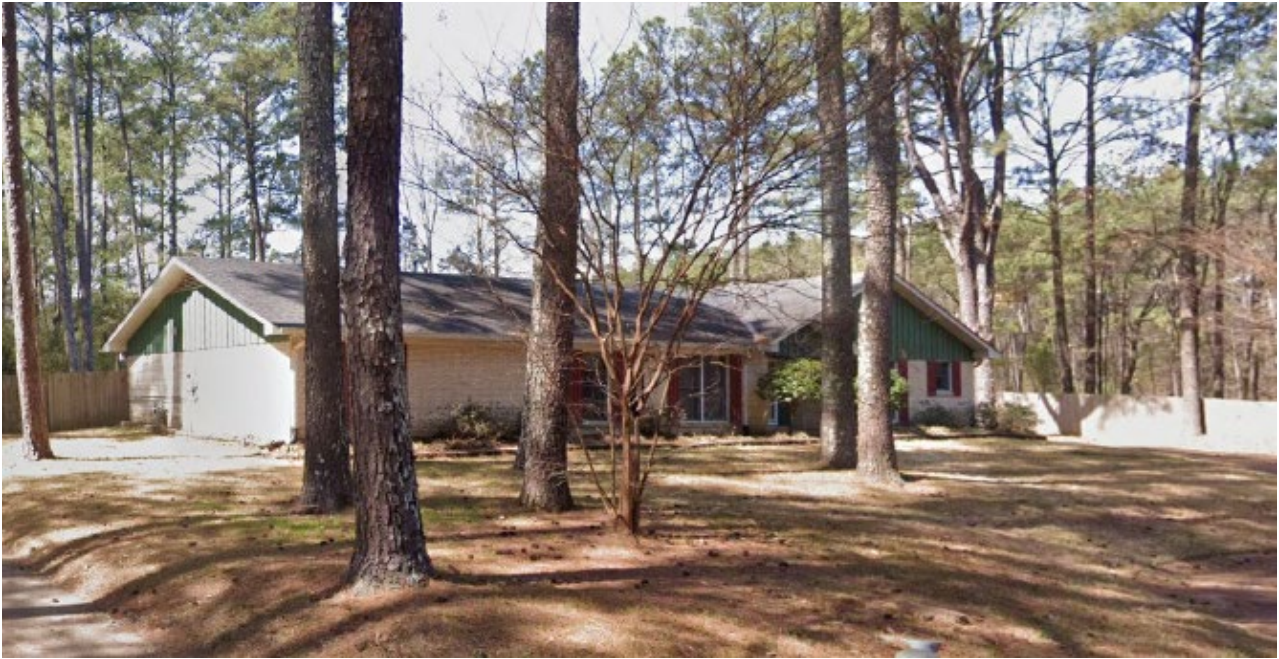
**Figure 2.** The Bristol Boulevard accident home before the explosion. (Courtesy of Google Maps.)

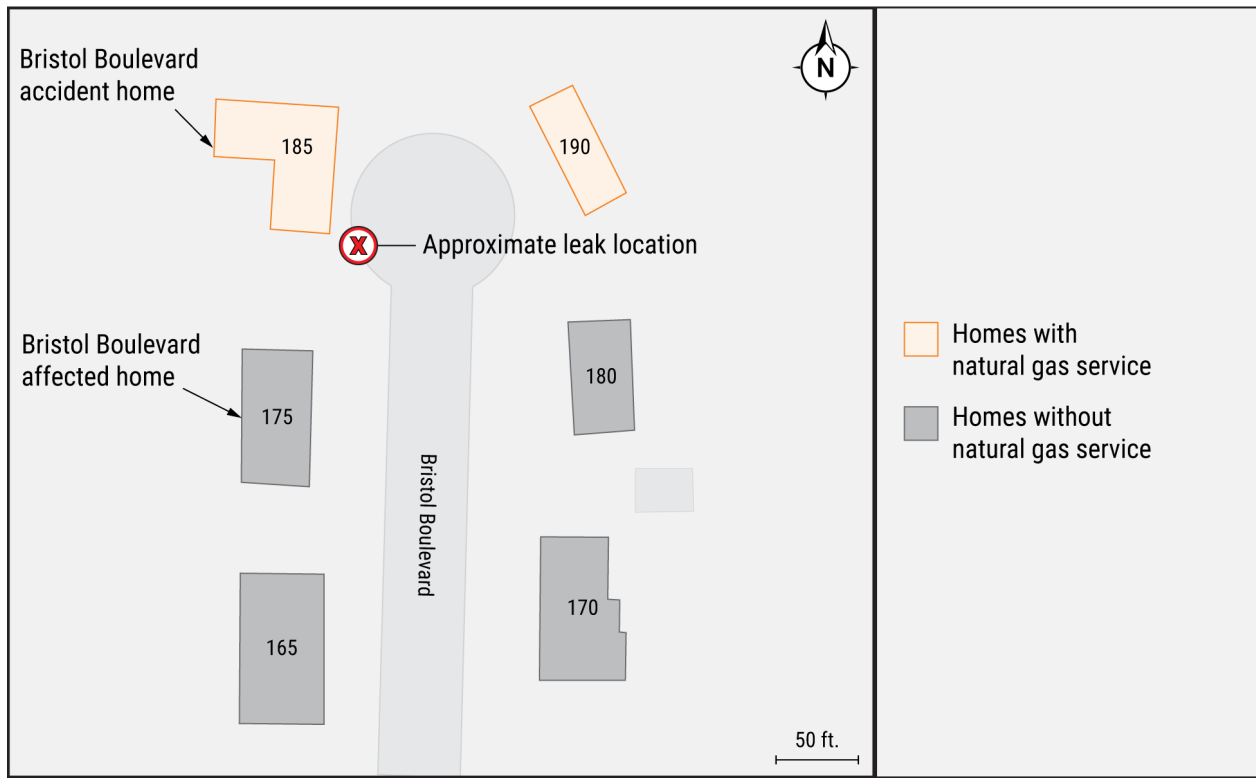
While Atmos provided natural gas service to the Bristol Boulevard accident home, it did not provide gas service to all the homes in the neighborhood, including the home at 175 Bristol Boulevard (Bristol Boulevard affected home), at which, postaccident, Atmos bar-hole testing detected explosive levels of natural gas.<sup>8</sup> Figure 3 shows the accident neighborhood, indicating the homes that had natural gas service and those that did not. It also shows the accident leak location, which will be discussed in section 1.6.1.1.2.

**Figure 3.** The Bristol Boulevard accident neighborhood.

Further pressure testing pinpointed the leak on the Dresser Style 90 straight compression coupling at the connection between the compression coupling and the service line to the home at 190 Bristol Boulevard. The compression coupling had not completely separated from the service line; the leak occurred in the space between the partially separated components. Figure 3, figure 10, and figure 11 show the approximate leak location.

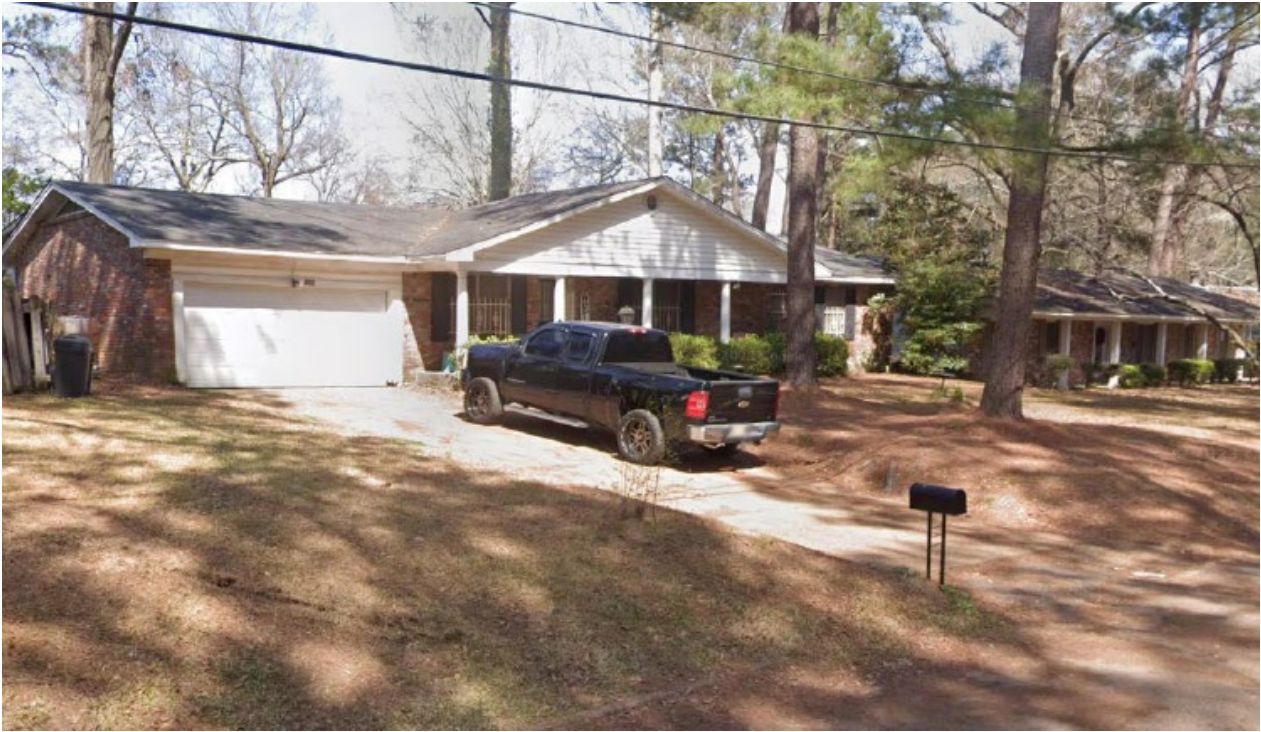
**Figure 5.** The Shalimar Drive accident home before the explosion. (Courtesy of Google Maps.)

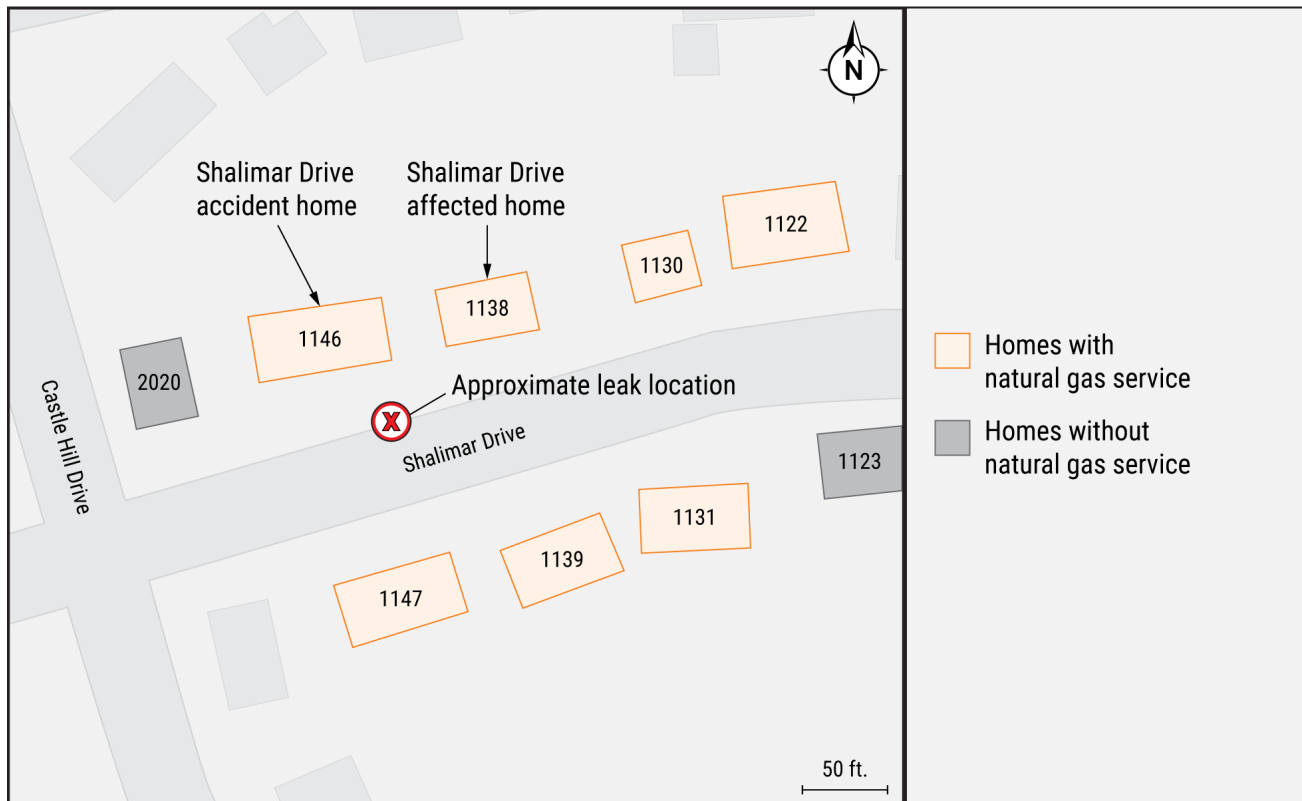
While Atmos provided natural gas service to the Shalimar Drive accident home and the home at 1138 Shalimar Drive (Shalimar Drive affected home), which caught fire during the accident, it did not provide gas service to all the homes in the neighborhood. Figure 6 shows the accident neighborhood, indicating the homes that had natural gas service and those that did not. It also shows the accident leak location, which will be discussed in section 1.6.1.2.2.

**Figure 6.** The Shalimar Drive accident neighborhood.

on the Dresser Style 90 elbow compression coupling at the connection between the compression coupling and the service line to the home at 1147 Shalimar Drive. The compression coupling had not completely separated from the service line; the leak occurred in the space between the partially separated components. Figure 6, figure 12, and figure 13 show the approximate leak location.

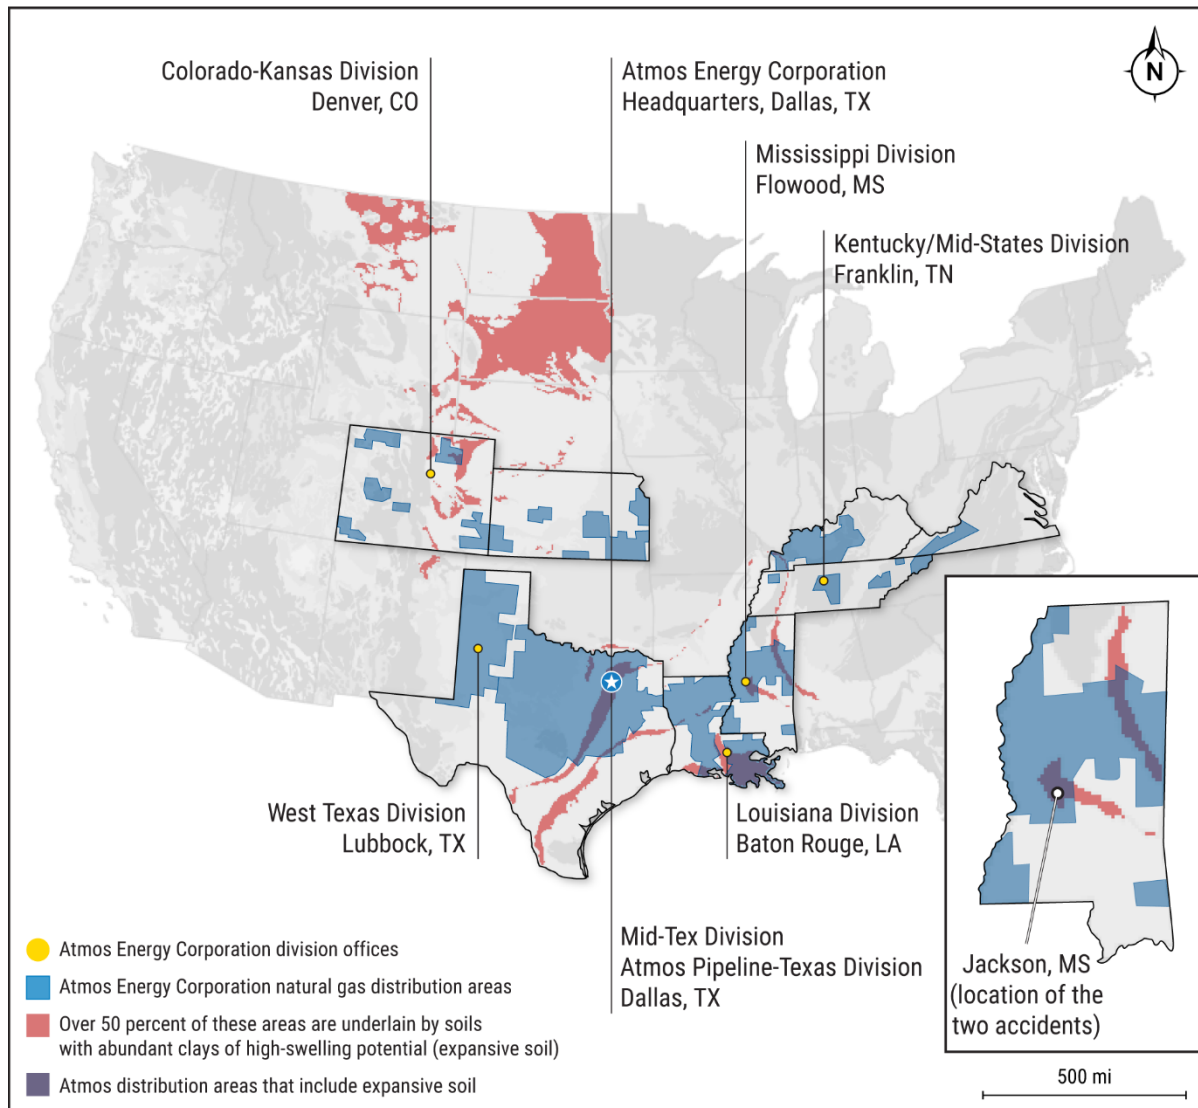
At the time of the two accidents, four of Atmos's six regional divisions, including the Mississippi Division, had distribution areas that included expansive soil, or what the US Geological Survey referred to as soil with "high-swelling potential." Figure 8 shows a US map of Atmos's headquarters and regional divisions transposed over a map of expansive-soil locations.

**Figure 8.** US expansive soil map overlaid with Atmos’s headquarters (starred) and regional divisions. (Courtesy of the US Geological Survey and Atmos with NTSB annotations.)

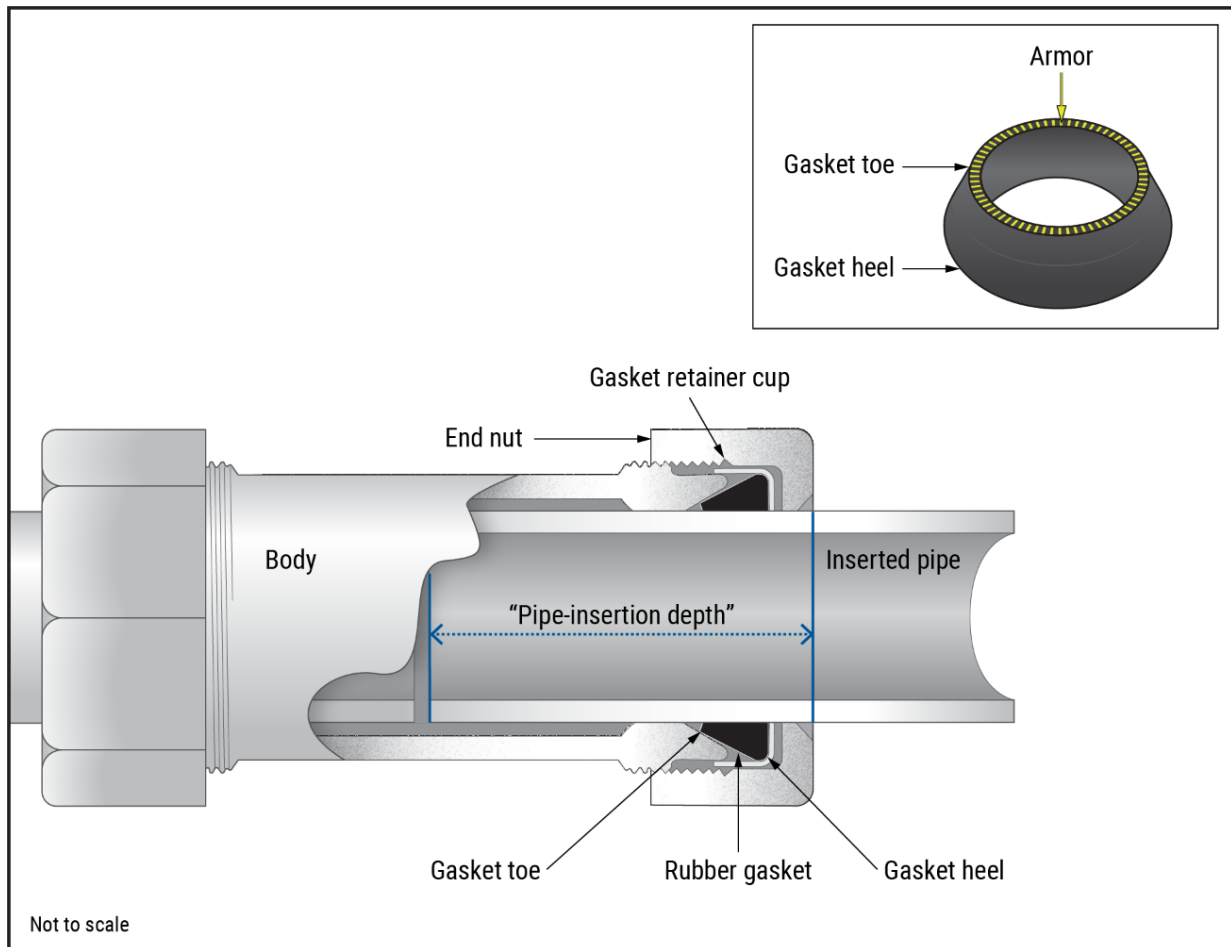
As discussed in section 1.1, Atmos's pipeline assets at the Bristol Boulevard accident home and the Shalimar Drive accident home included Dresser Style 90 compression couplings. A Dresser Style 90 compression coupling is composed of a coupling body, gasket, gasket retainer cup, and end nut. The gasket is tapered at one end (the "toe") and flat at the other (the "heel"). The gasket toe contains a tightly wound coil of metal that runs around its circumference called "armor."<sup>38</sup> The retainer cup presses against the heel, and the end nut presses against the cup. A technician inserts the pipe into the end of the coupling and then tightens the nut down, compressing the gasket between the pipe and the coupling, creating a seal.<sup>39</sup> Figure 9 shows a schematic cross section of a Dresser Style 90 compression coupling, highlighting the armor in the gasket toe.

**Figure 9.** A Dresser Style 90 compression coupling.

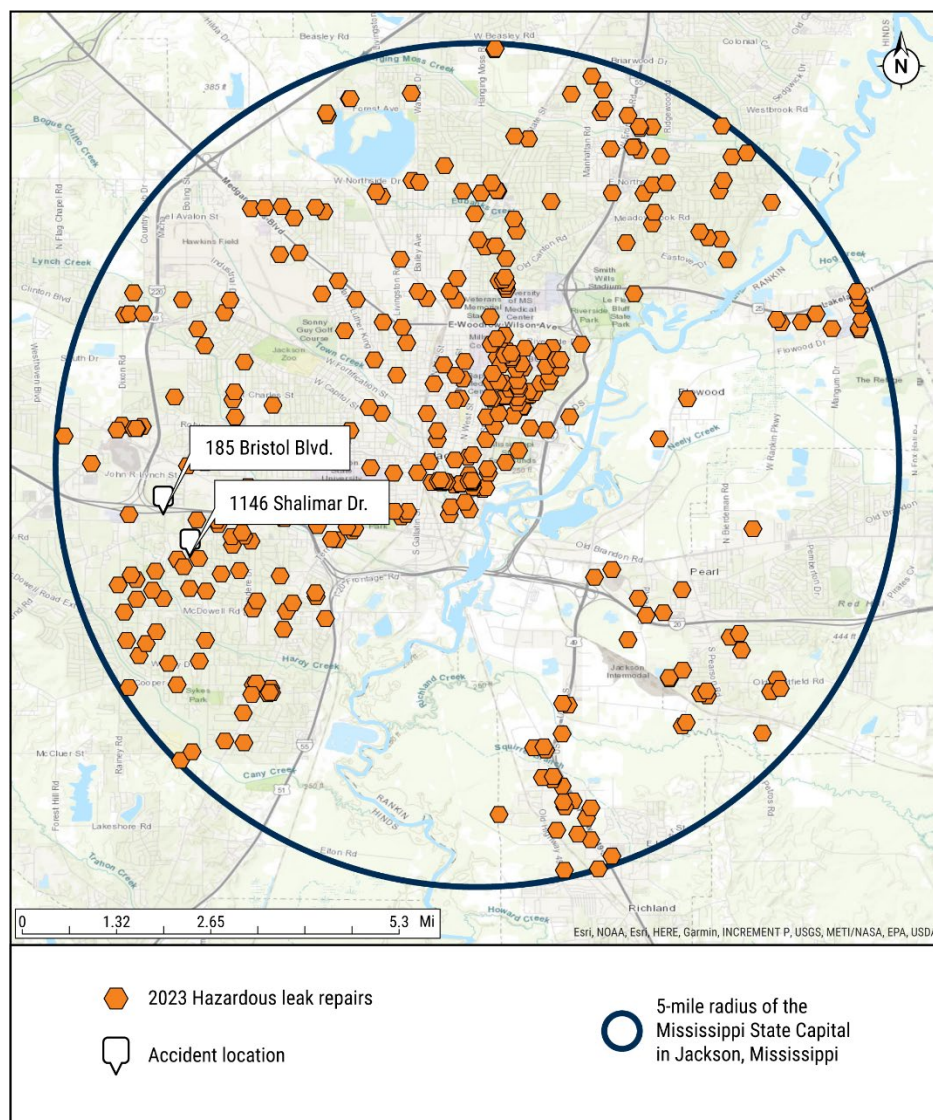
Atmos's procedures stated that leak management was accomplished by leak surveying and involved locating, grading (or classifying), repairing, and monitoring leaks. In 2023, the year before the two Jackson accidents, Atmos repaired 182 hazardous (grade 1) leaks in Jackson. (See figure 20.) (As discussed in section 1.1, this report's references to leaks refer to belowground leaks unless otherwise noted.)

**Figure 20.** Map of hazardous leaks within a 5-mile radius of Jackson that Atmos repaired in 2023. (Courtesy of ESRI ArcGIS and Atmos with NTSB annotations.)

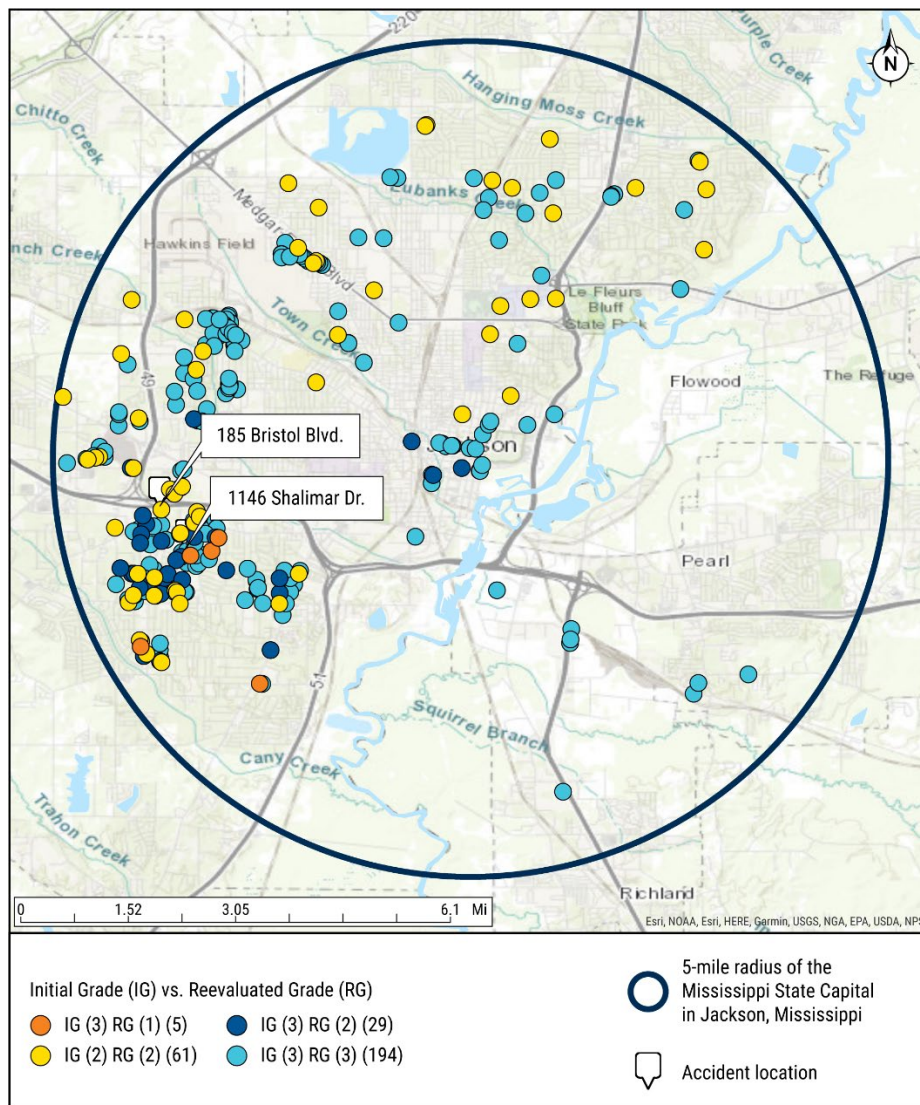
classified several leaks as grade 3 leaks that upon reevaluation in the field met the criteria for grade 1 or grade 2 leaks.<sup>72</sup> Figure 21 shows a map of the 289 open leaks in Jackson as of January 24, 2024, including the two accident locations, and the grade 3 leaks that met the criteria for higher grade leaks when Atmos reevaluated them.<sup>73</sup>

<sup>72</sup> Five of the 228 leaks that Atmos had previously classified as grade 3 met the criteria for grade 1 leaks, and 29 of the 228 leaks that Atmos had previously classified as grade 3 met the criteria for grade 2 leaks. Therefore, about 15% of the grade 3 leaks Atmos had identified as of January 24, 2024, met the criteria for higher grade leaks when Atmos reevaluated them.

**Figure 21.** Map of open leaks within a 5-mile radius of Jackson on January 24, 2024, including leaks that later met criteria for higher grade leaks. (Courtesy of ESRI ArcGIS and Atmos with NTSB annotations.)

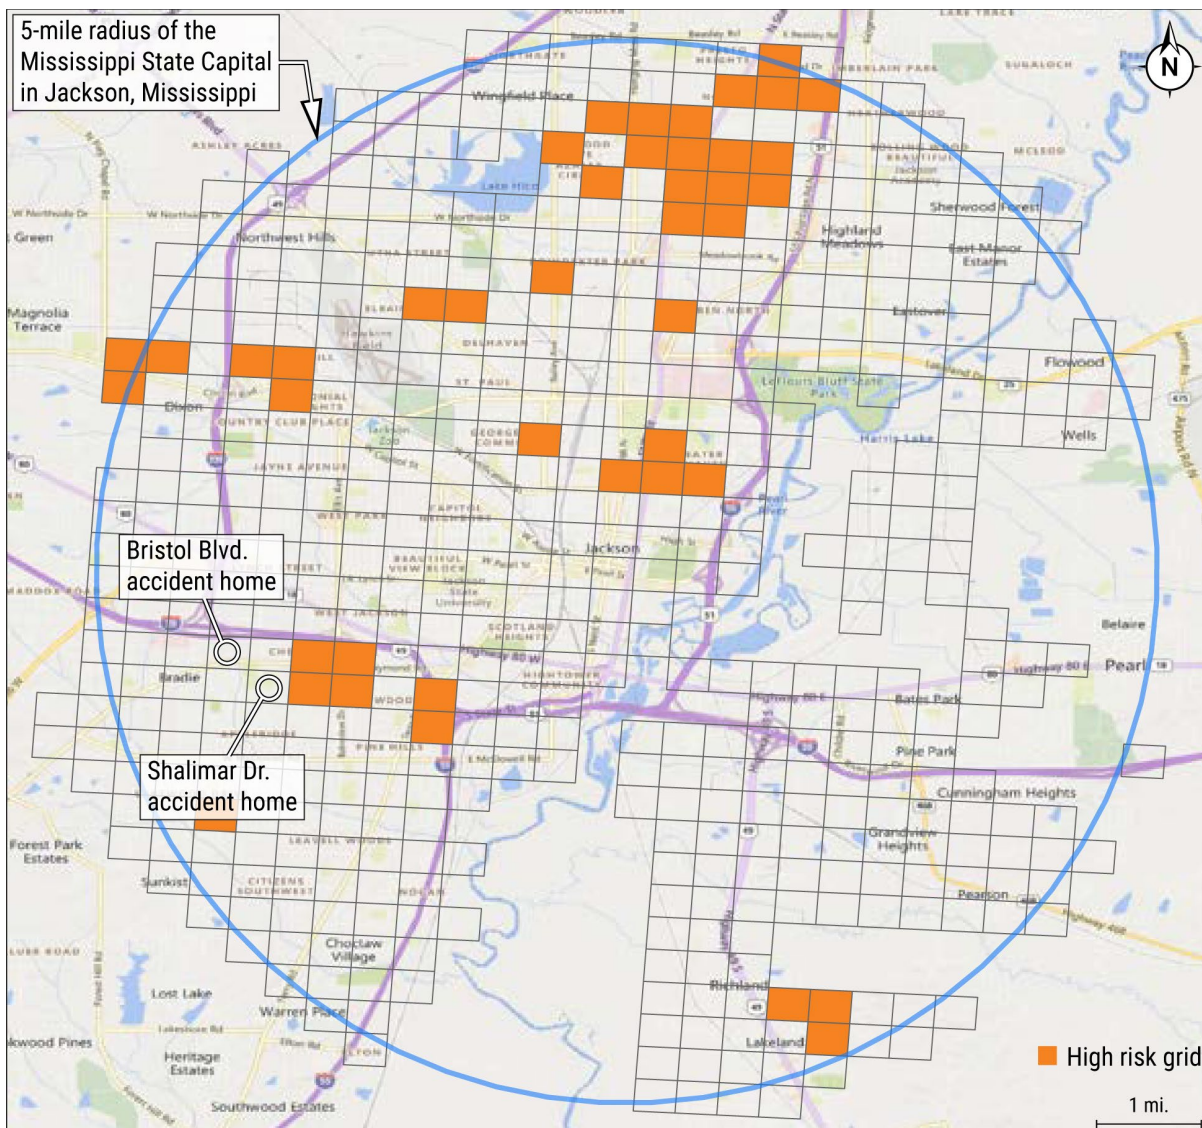
identify the accident locations as high risk.<sup>102</sup> The risk model output was a listing of high-risk grids, not a pictographic display as shown below. The NTSB developed this figure using a listing of the high-risk grids in Jackson.

**Figure 22.** Map of the Atmos risk model's high-risk grids in Jackson as of January 24, 2024. (Courtesy of Atmos with NTSB annotations.)

<sup>102</sup> (a) High risk was the only designator that Atmos's risk model used; the model considered risk grids that were not identified as high risk, such as the two accident location grids, as normal risk. (b) The Atmos risk model's high-risk grids that were current on January 24, 2024, were the same high-risk grids that were current at the end of 2023.

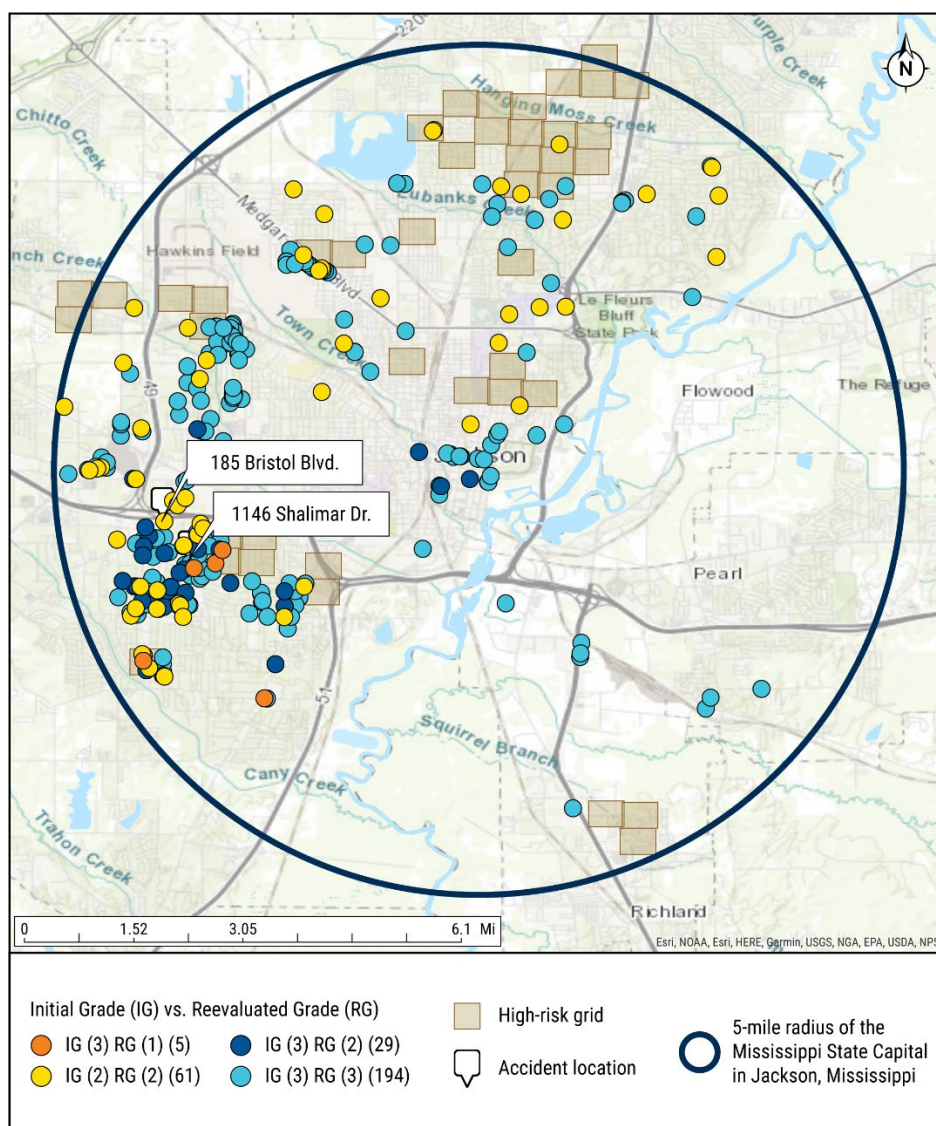
radius of Jackson, including the accident leaks. On January 24, 2024, the Bristol Boulevard accident occurred. Three days later, on January 27, 2024, the Shalimar Drive accident occurred. Although these two catastrophic accidents were confirmed risks to Atmos's system, resulting from (open) leaks that Atmos was aware of, its risk model did not rank the accident locations as high risk. Figure 24 shows the open, nonhazardous leaks within a 5-mile radius of Jackson as of January 24, 2024, overlaid with the Atmos risk model's high-risk grids that were current on that date; not many of the open, nonhazardous leaks, including the accident leaks, are in high-risk grids. The figure also shows the grade 3 leaks that met the criteria for higher grade leaks (grade 1 and grade 2 leaks) when Atmos reevaluated them.<sup>126</sup>

**Figure 24.** Map of open, nonhazardous leaks within a 5-mile radius of Jackson as of January 24, 2024, including leaks that later met criteria for higher grade leaks, overlaid with Atmos high-risk grids current on that date. (Courtesy of ESRI ArcGIS and Atmos with NTSB annotations.)
